Evaluation Report

Risk of Asbestos Exposure, Illegal Dumping, and Contaminated Soil From Demolitions in Flint, Michigan and Other Cities

SUBJECT: Risk of Asbestos Exposure, Illegal Dumping, and Contaminated Soil From
Demolitions in Flint, Michigan and Other Cities
(SIGTARP 18-002)

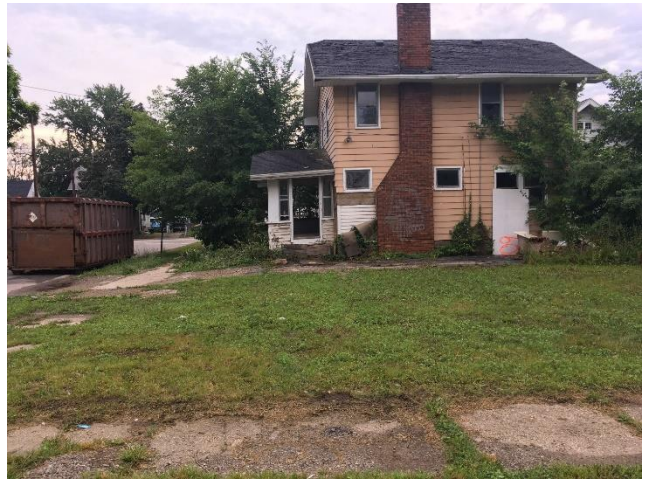
Figure 1: 1909 Becker Street

First house to be inspected was at 1909 Becker Street in Flint (Figure 1). This site was scheduled for demolition on this day (12/July) there was a dumpster placed in front of the residence but no contractors were onsite. We visited several properties in different phases of deconstruction. Some properties were just abated (Figure 7) the asbestos siding and the interior plaster walls had been removed and placed (per neighbors) in a dumpster marked for asbestos that was placed in front of the residence on (Brown street).

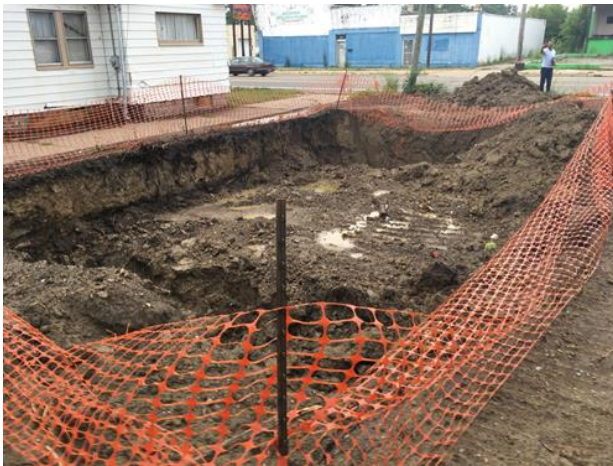
Figure 2: Site on Corunna awaiting backfill

At a site on Corunna (Figure 2) the residence had been demolished and all the debris had been removed. A clean hole (with no debris or remnants of the basement) was all that remained. We visited several sites in Flint on Caldwell (Figure 3 and 4), Lyons, Swayze, Brown and Becker (Figure 1) streets in different phases of demolition. On Swayze one had a hole similar to Corunna (Figure 2) and had one property that was completed with the ground leveled covered with clean fill that was seeded with a straw cover. We visited a couple more completed sites and a couple more that had open holes.

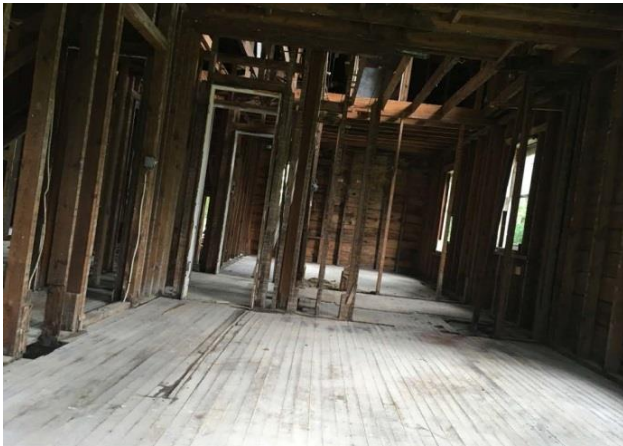
Figure 7: 3106 Grand Traverse abated interior prior to demolition

At 3016 S Grand Traverse (Figures 7 and 8) Salenbien Trucking, the demolition company, arrived with a water truck and an excavator to begin demolishing the house there. They demolished the house within an hour. I talked briefly with Salenbien foreman (Russ David). During the conversation, I learned that the Genesee County Land bank requires several inspections during demolition. They inspect the house after abatement, and after debris removal. Before the basement can be filled, the Land bank inspects the excavation to make sure it is clean and free of all construction debris before it can be filled.
