Special Inquiry into the U.S. Nuclear Regulatory Commission's Oversight of Research and Test Reactors

OIG Case No. I2100162
September 29, 2023

SUBJECT: SPECIAL INQUIRY INTO THE U.S. NUCLEAR REGULATORY COMMISSION'S OVERSIGHT OF RESEARCH AND TEST REACTORS (OIG Case No. I2100162)

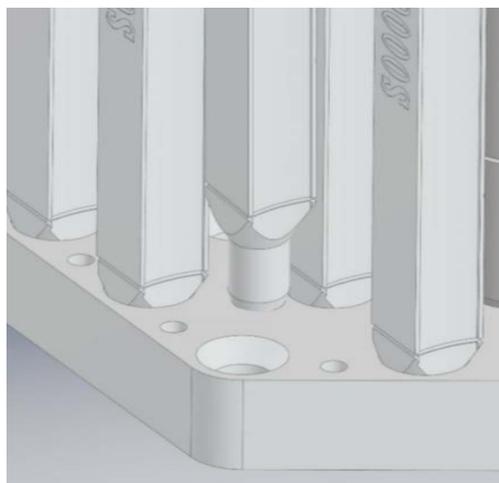
Figure 1: Misaligned fuel element

Therefore, the licensee was required to remain shut down until the NRC authorized restart of the reactor. NIST officials also determined that its licensed operators failed to ensure a fuel element was fully latched in its designated core position at the end of refueling operations on January 4, 2021. Between January 4, 2021, and February 3, 2021, the unlatched fuel element became misaligned due to NIST operators starting and stopping primary pumps to maintain required temperatures. During reactor start-up on February 3, 2021, at approximately 50 percent power (10 MW), this fuel element did not receive sufficient cooling because it was not in the proper orientation to receive design cooling water flow (see Figure 1). As a result, the fuel element partially melted.

Video surveillance of this and all other checks shows that the latch checks were performed improperly: (1) the tool was rotated in the wrong direction, and (2) the rotation orientation check used an improper reference. In addition, the subsequent check of height of J-7 (a check to see if the tool collar was flush with the index plate) was found to be slightly high. This was attributed to the longer new tools. The effect of this improper check is uncertain but could possibly have worsened the condition of a partially latched element, rotating it towards a more fully unlatched position.¹²

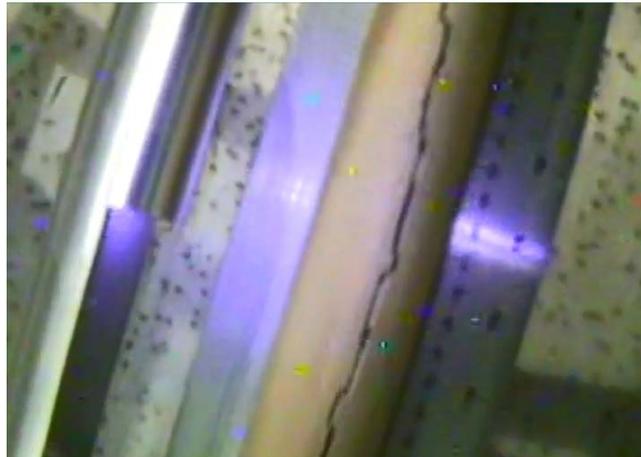
Figure 4: Aerotest cracked fuel element

Contrary to NRC reporting, the OIG reviewed the Aerotest Data Sheets for Fuel and Graphite Transfer for the 2007 inspection and found 20 fuel elements and 5 graphite elements were indicated as stuck in the reactor core. The OIG also found that one sheet listed “crack” in the Comments section for element 631E, and that this element had been removed from the core and placed into a storage rack.

identified by Aerotest staff as cracked had been reported on the Data Sheets for Fuel and Graphite Transfer as stuck since 1994.²⁰ Of the 17 fuel elements that were inside the reactor core at the time of discovery, 14 had been previously indicated as stuck on the Data Sheets for Fuel and Graphite Transfer.

On December 18, 2013, approximately 3 years after Aerotest voluntarily ceased operation of the reactor, the NRC issued Aerotest a Notice of Violation against Technical Specification 10.2. The violation stated that “from an indeterminate period of time beginning at a point after the last full inspection in 2006 up until October 15, 2010, when the facility ceased reactor operation, the licensee operated the reactor with significant defects in the fuel elements.” The first 4 cracked elements were discovered in late 2011, and in a subsequent inspection, 22 fuel elements were identified as having varying degrees of discoloration, blistering, swelling, and/or cracking in the aluminum cladding (see Figure 4). These characteristics represented a significant defect in the fuel elements and the loss of the integrity of a fission product barrier.
