(U) Audit of the Army's Management of Army Prepositioned Stock-5 Equipment

(U) Audit of the Army's Management of APS-5 Equipment

May 24, 2024

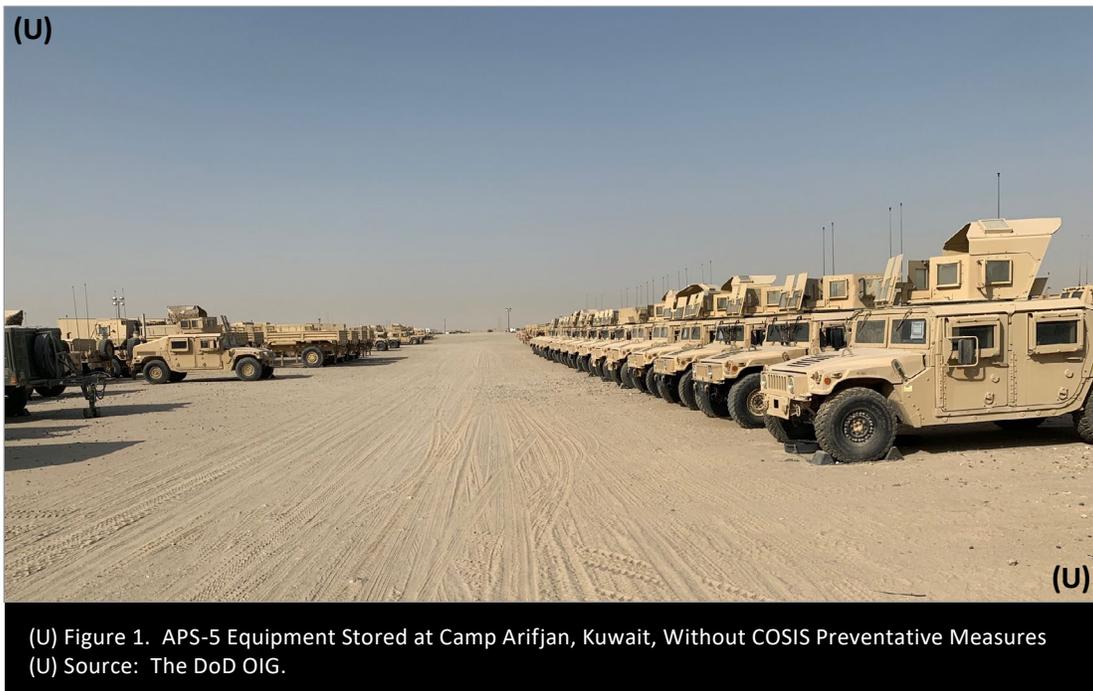
(U) The APS-5 contractor did not protect 5,885 pieces of APS-5 equipment from environmental conditions or prevent corrosion and degradation, as required by Army TM 38-470. To prevent deterioration

(U) The APS-5 contractor did not protect 5,885 pieces of APS-5 equipment from environmental conditions or prevent corrosion and degradation.

(U) Army TM 38-470 states that equipment placed in open storage must be protected from environmental elements, such as wind and sand, using plastic tarps, plastic sheeting, or any other barrier material. Furthermore, the APS-5 contract requires the contractor to use barrier material to cover windows, placing the material between windshield wipers and the glass, to prevent the wipers from sticking to the window seal and protecting the equipment from ultraviolet rays. However, we observed that none of the APS-5 equipment stored outside, such as HMMWVs and M1000 semitrailers, had the tires or windows covered to protect the equipment from environmental conditions. APS-5 contractor officials acknowledged that none of the 5,885 pieces of APS-5 rolling stock were stored in accordance with Army TM 38-470 or the APS-5 contract specific preventative measures since 2017. The 401st AFSBn-Kuwait COR stated that they were aware that the APS-5 contractor was not complying with all COSIS requirements; however, 401st AFSBn-Kuwait did not enforce the requirements because it believed it would be too expensive.¹⁹ The 401st AFSBn-Kuwait did not have an approved waiver for deviation from the COSIS requirements. Figure 1 shows APS-5 equipment stored outside without covered tires or windows to protect equipment from the environmental conditions, such as extreme heat and dust.

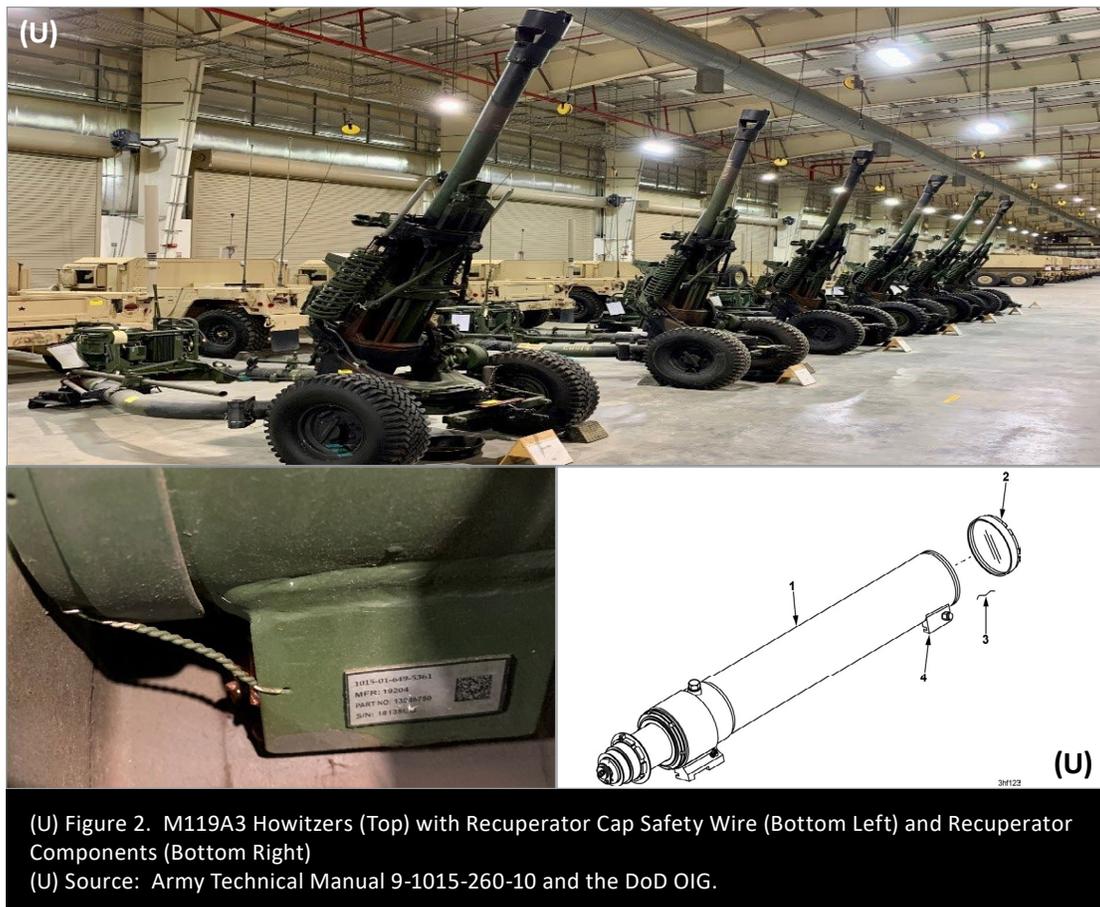
(U) For example, the APS-5 contractor did not adequately maintain five M119A3 howitzers in accordance with the equipment-specific technical manual.²³ From May 6, 2022, through June 27, 2022, the APS-5 contractor documented completing the annual maintenance on the five M119A3 howitzers, during which the contractor reported servicing the howitzer recuperators and repairing all deficiencies to bring the howitzers to a fully mission capable status.²⁴ However, on September 6, 2022, we found that the recuperator cap safety wires had not been removed, which is necessary to service the recuperator and bring the equipment to a fully mission

²⁴ (U) The recuperator is a vital piece of the M119A3 howitzer recoil system, which is used to absorb the force from firing and allows the howitzer to return to a ready to fire position.

(U) capable status. We observed, with a Howitzer Specialist from the U.S. Army Tank-Automotive and Armaments Command, that the safety wires had chipped paint and other indicators of wear, indicating that the APS-5 contractor did not cut the safety wire to service the howitzer, and then insert a new safety wire. The howitzer equipment-specific technical manual states that not performing maintenance to the recuperator results in the howitzer being non-mission capable. See Figure 2 for a picture of the M119A3 howitzers and recuperator cap safety wire at Camp Arifjan, Kuwait, and a graphic of the recuperator (1), recuperator cap (2), safety wire (3), and recuperator mounting bracket (4).

(U) In one instance in June 2022, the 401st AFSBn-Kuwait CORs signed a work order acknowledging that the APS-5 contractor had repaired a M119A3 howitzer to fully mission capable status, including removing the recuperator caps to check the nitrogen pressure. However, we observed that the lacing from the howitzers’ recuperator caps had not been recently removed and replaced, indicating that the APS-5 contractor could not have removed the cap to check the nitrogen pressure. The equipment-specific technical manual states the howitzer is non-mission capable if the nitrogen pressure is not checked.

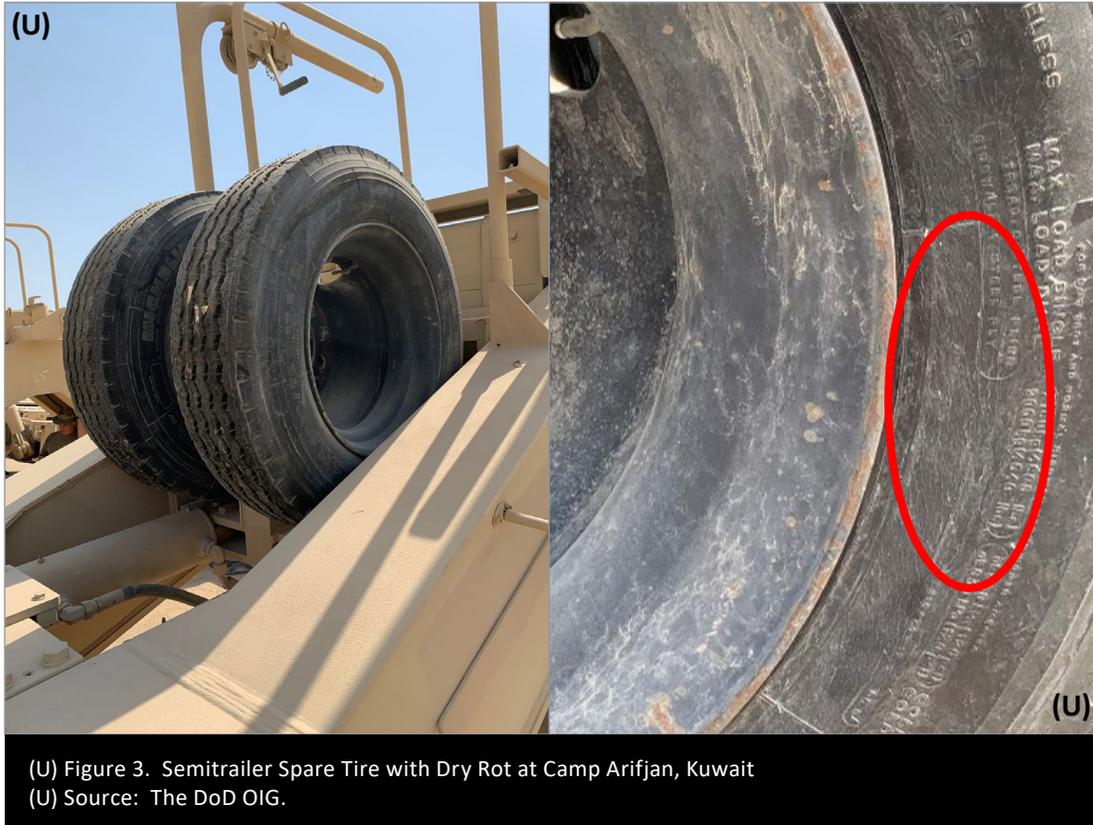
(U) In addition, a March 25, 2022 M1000 semitrailer maintenance record stated that the APS-5 contractor replaced both spare tires with newly ordered tires because the tires were damaged by dry rot. However, during our inspection on September 2, 2022, we found that the APS-5 contractor did not replace the spare tires and that both spare tires were damaged by dry rot. Officials from the 401st AFSB and 401st AFSBn-Kuwait agreed that if the APS-5 contractor had replaced both tires as the maintenance records stated, the tires would not have visible dry rot within 6 months. Therefore, the APS-5 contractor could not have

(U) replaced both spare tires. The 401st AFSBn-Kuwait maintenance officer acknowledged that the APS-5 contractor did not replace the spare tires as stated in the maintenance record and could not explain why the 401st AFSBn-Kuwait COR signed off that the work was completed. Figure 3 shows the dry rot on the M1000 semitrailer spare tire at Camp Arifjan, Kuwait.
