**OFFICE OF INSPECTOR GENERAL**

# INSPECTION REPORT

DOE-OIG-24-26

**LAWRENCE BERKELEY NATIONAL  
LABORATORY SHOULD ENSURE  
PROPER MONITORING OF WORKERS  
FOR RADIATION EXPOSURE WHEN  
PROCESSING PACKAGES**

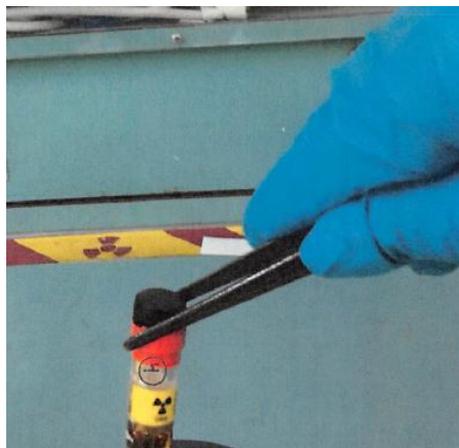
On October 6, 2020, two RCTs surveyed a package containing two vials of Ce-134. One RCT removed each vial from its individual lead shielding to determine contamination levels and dose rates. After reviewing the data, the RCT concluded that the dose rate numbers they had written down were too low for the amount of material surveyed. Then, the RCT conducted a second survey by removing the higher activity vial from its shielding again. The vial measured a dose rate of 500 mrem per hour at 30 centimeters (cm) from the vial. The dose rate is the dose of radiation delivered per a unit of time. For example, a dose rate of 500 mrem per hour for a full hour exposes the worker to an estimated dose of 500 mrem.

**FIGURE 1: RCT REMOVING VIAL OF CE-134 FROM SHIELDING.**

LBNL did not control the area or perform monitoring and testing as required when the RCTs' survey measured above the threshold for an HRA. 10 CFR 835.2 defines an HRA as any area accessible to individuals in which radiation levels could result in an individual receiving an equivalent whole body dose in excess of 100 mrem in 1 hour at 30 cm from the radiation source. When the conditions for an HRA exist, 10 CFR 835.502 requires monitoring as necessary during access to determine exposure rates and provide an immediate estimate of the integrated equivalent dose to the whole body during entry in the area. The Department's Office of Environment, Health, Safety and Security management stated that the requirement is not a single dose rate, "but rather a cumulative potential dose (i.e., how much dose someone would have received if they were 30 cm from the source over a 1-hour time frame)." However, 10 CFR 835 establishes that HRA conditions exist when radiation levels could result in an individual receiving the identified dose if the exposure lasted an hour. The OIG interprets 10 CFR 835 as not requiring exposure to last an hour before implementing the required safety controls. Further, the determination whether radiation levels could result in an individual receiving an equivalent whole body dose in excess of 100 mrem in 1 hour at 30 cm should be calculated prior to exposure (i.e., before the package is opened). If it is determined that such exposure could occur, the package should be opened in an HRA. Also, when radiation is unexpectedly encountered

1. RPG complies with 10 CFR 835 requirements, including requirements pertaining to opening packages containing material that may emit radiation above the threshold for an HRA;
2. RPG's procedures are updated to reflect improvements identified in this report and in the critique, including adequate planning for the receipt and survey of material that could exceed HRA thresholds;
3. RCTs follow procedures when receiving radiological materials that differ from authorized amounts;
4. The policy related to gloveboxes is revised to ensure that radiological conditions are adequately monitored inside gloveboxes, as required by 10 CFR 835, and ensure that workers are aware of those conditions; and
5. Staff use the electronic inventory system when receiving packages, as required by RPG procedures.

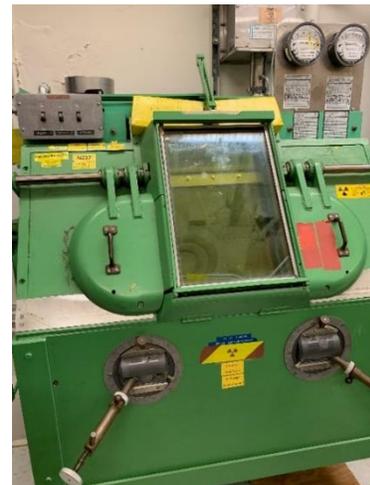
During a routine survey in December 2021, an RCT identified a possible radiation area when the sleeve ports of a shielded glovebox were left open and radiation levels measured above 5 mrem at the sleeve port. An RCT expressed concerns about workers' whole body exposure and proper glovebox monitoring. The concerns raised by the RCT resulted in a critique held by RPG officials in January 2022; however, the critique did not address the RCT's concerns about radiation exposure and glovebox monitoring. Instead, the critique focused on posting gloveboxes as radiation areas, but it concluded that there was no need to do so because LBNL states that the definition of an area does not include gloveboxes.

FIGURE 2: SHIELDED GLOVE BOX  
SOURCE: OIG INSPECTOR

**Recommendation 4:** To further improve radiation protection at LBNL, we recommend that the Manager, Berkeley Site Office, direct the University of California to ensure that the policy related to gloveboxes is revised to ensure that radiological conditions are adequately monitored inside gloveboxes, as required by 10 CFR 835, and ensure that workers are aware of those conditions.

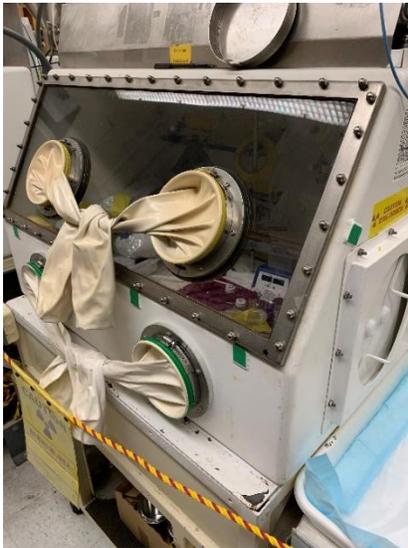
LBNL officials stated that they actively monitor radiological conditions on external surfaces of gloveboxes but not within them. Specifically, RPG officials stated that radiological workers take radiation readings at the sleeve openings of the glovebox and 30 cm from the sleeve openings, but the workers do not survey inside the sleeves or take readings within the glovebox.

FIGURE 3: STANDARD GLOVE BOX  
SOURCE: OIG INSPECTOR
