# **National Park Service Employees Violated Federal and National Park Service Regulations During Cleanup Efforts at Virgin Islands**

# REPORT OF INVESTIGATION

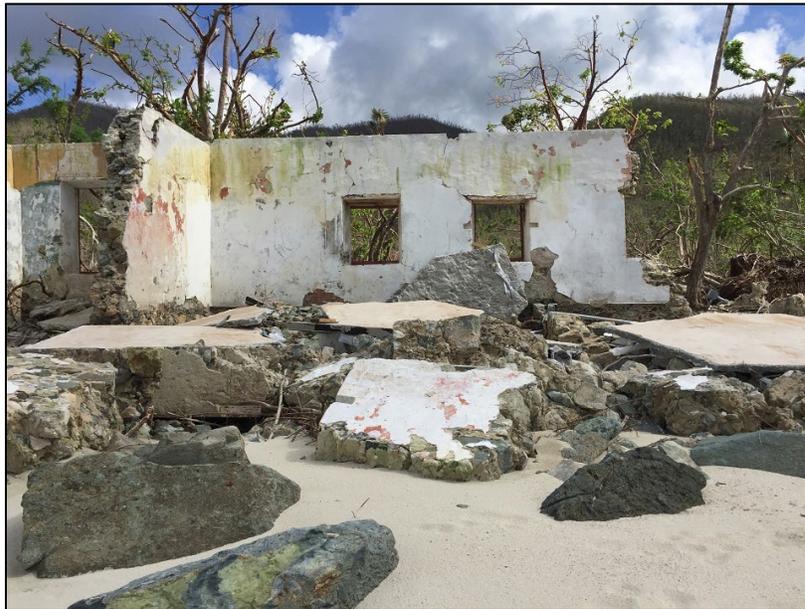
archeological structures (see Figure 2), but many of the archeological artifacts lay underground and were unaffected by the hurricanes.<sup>2</sup>

**Figure 2: Damage to the Cinnamon Bay Museum as a Result of the Hurricanes**

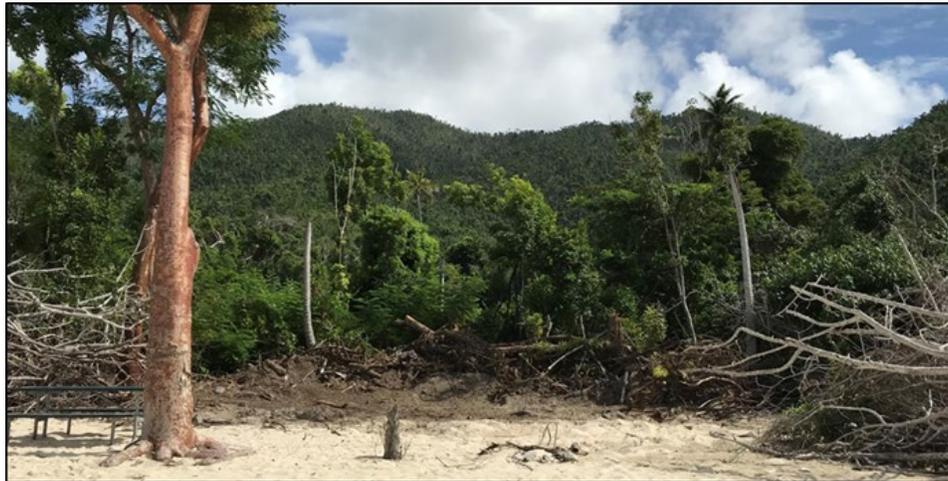
Despite these emergency cleanup efforts in fall 2017, Cinnamon Bay remained closed to the public, and much of it was still covered by debris from fallen trees and other materials (see Figure 3). Tourism is a leading contributor to St. John’s economy, which suffered when the damages from these hurricanes forced sites like Cinnamon Bay to close. Therefore, according to VIIS leadership, pressure mounted from NPS headquarters, Virgin Islands’ politicians, and St. John’s citizens to reopen Cinnamon Bay. In response, the NPS senior official launched a second cleanup effort in 2018.

**Figure 3: Fallen Trees and Debris Remaining After the 2017 Cleanup Efforts**

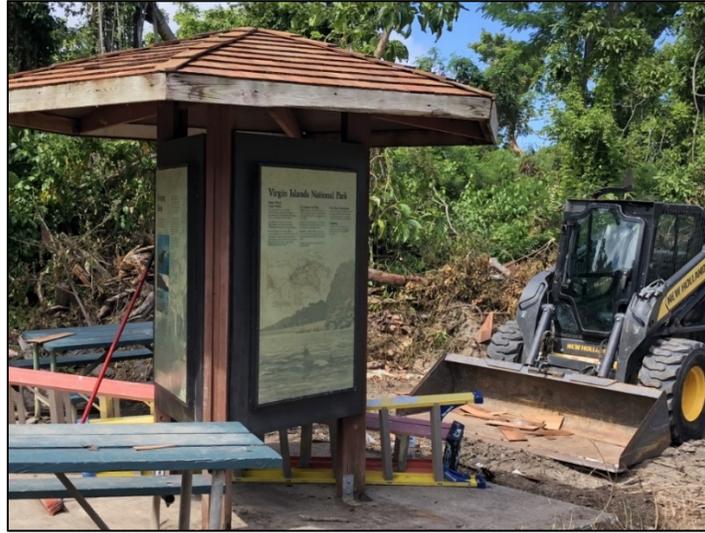
The crew members told us they used the bobcat and backhoe to move debris and push it into berms. The area where the crew members used the heavy equipment included historically sensitive sites where archeological artifacts lay underground and near the surface (see Figure 4). As the crew used the equipment, the bobcat's and backhoe's buckets scraped the surface, causing visible disruptions on the ground (see Figure 5). Crew members told us they could see the equipment's tire tracks as they moved the equipment. Some crew members also told us they had no knowledge of Cinnamon Bay's archeological resources. The VIIS employee, who, as noted previously, expressed to us the belief that one of the crew members was leading the project, described providing the crew with equipment but denied playing any role in supervising the crew's use of it.

**Figure 4: Heavy Equipment Onsite at Cinnamon Bay**

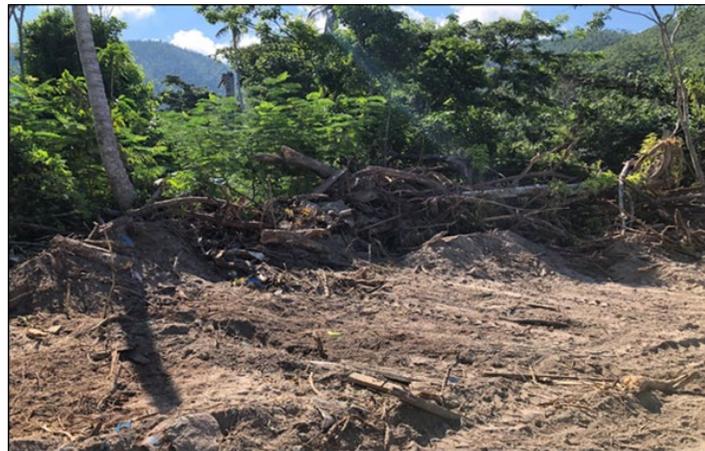
**Figure 5: Visible Tracks Made by Heavy Equipment Used at Cinnamon Bay**

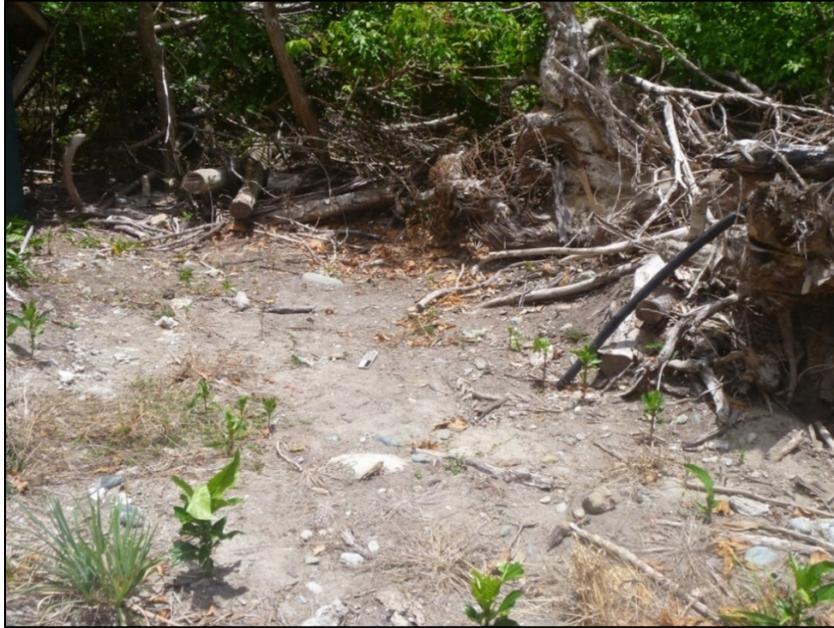
After the NPS employee’s conversation with the VIIS employee, the NPS employee visited Cinnamon Bay the next day to see what work had been done and discovered damage in the area. The NPS employee photographed and documented several artifacts exposed on the ground surface (see Figure 6).

**Figure 6: The Debris Pushed Into a Pile Exposed Historic Artifacts**

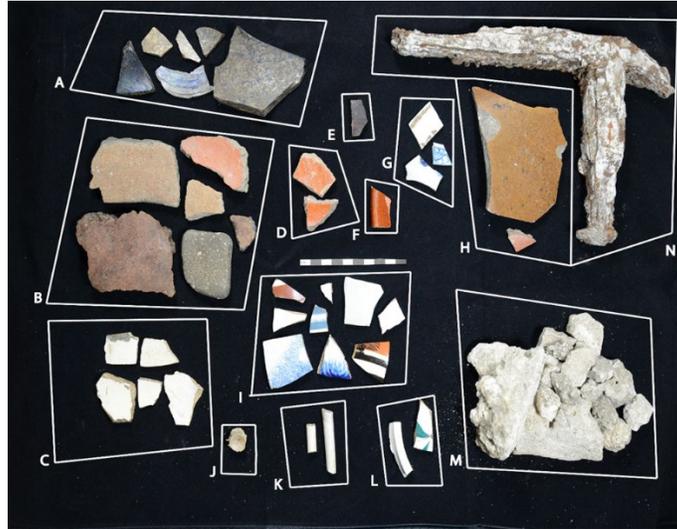
In winter 2018, an archeological team assessed the damage at Cinnamon Bay. As part of the assessment, the team took small samples of each of the excavated piles and screened the soils for objects. According to an archeologist, the team found more than 400 prehistoric and historic artifacts, such as pottery and stoneware dating back to as early as 1550 (see Figure 7). While the archeologist did not know the exact number of artifacts affected by the crew's work, based on sampling, the archeologist determined that the project caused serious damage to the archeological resources at Cinnamon Bay and estimated that a backhoe disturbed nearly 6,000 square feet of soil.

**Figure 7: Artifacts Recovered by the NPS Archeologists at Cinnamon Bay**

- Group A: Historic Glass
- Group B: Pre-Historic Pottery Sherds
- Group C: Historic Pottery Sherds; Creamware 1762-1820
- Group D: Historic Pottery Sherds; El Morro Ware 1550-1700
- Group E: Historic Pottery Sherd; Lead-Glazed Coarse Earthenware 1490-1900
- Group F: Historic Pottery Sherd; Reyware 1725-1825
- Group G: Historic Pottery Sherds; Porcelain 1500-Present
- Group H: Historic Pottery Sherds: Brown Salt Glazed Stoneware 1690-1775
- Group I: Historic Pottery Sherds; Pearlware 1780-1840
- Group J: Fish Bone
- Group K: Clay Pipe Stems 1/16th Diameter 1750-1800
- Group L: Historic Pottery Sherds; Whiteware 1830-Present
- Group M: Lime Mortar
- Group N: Metal Door or Window Pintal

In summer 2019, the archeologist produced a damage assessment report that cited damage made by heavy equipment used to scrape and excavate soil and to push trash, soil, and vegetation into piles. The report assessed the monetary damages at the site under ARPA by combining the cost
