Office of Audits  
Office of Inspector General  
U.S. General Services Administration

# Building Maintenance Contractors Are Not Complying with Their GSA Contracts Due to Poor Performance and Ineffective Oversight

Report Number A230032/P/2/R24004  
May 3, 2024

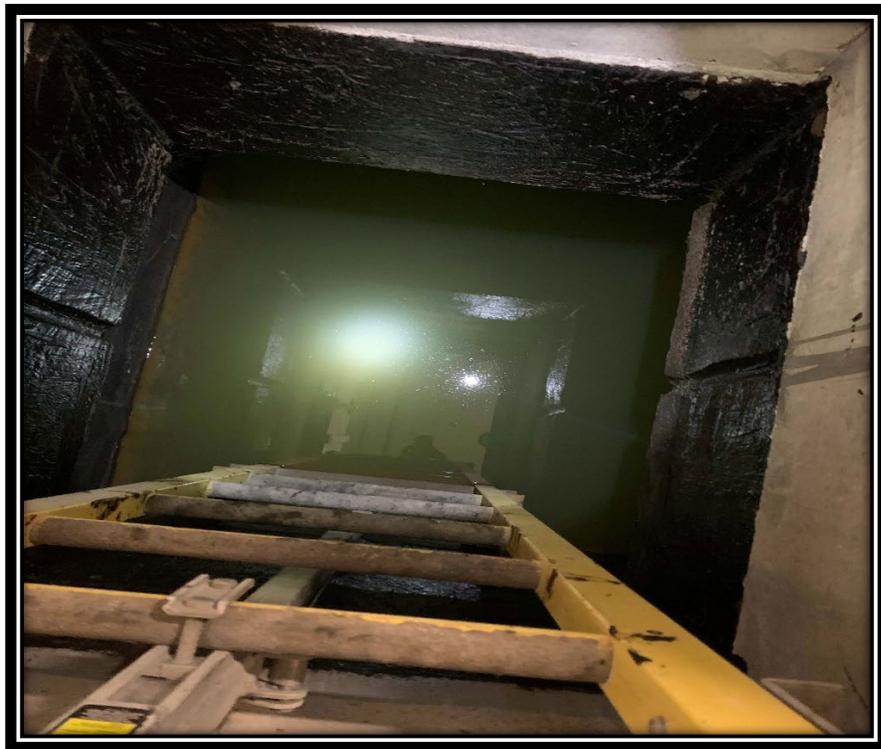
**Figure 1 – Fire System Water Tank at Edith Green-Wendell Wyatt Federal Building<sup>2</sup>**

- **Preventive Maintenance Work Order: Fire System Water Tank – Edith Green-Wendell Wyatt Federal Building, Portland, Oregon** – The building’s fire suppression system includes a water tank that is designed to provide a reliable backup source of water for the building’s fire suppression system. According to the PBS preventive maintenance standard listed on the NCMMS work order, the tank should be drained, inspected for any cracks, and thoroughly cleaned every 3 years.<sup>1</sup>

We observed the tank during our site visit on May 23, 2023. As shown in *Figure 1*, the water in the tank was murky, indicating that the O&M contractor had not cleaned the tank in a long time.

The O&M contractor marked this work order as complete in August 2022; however, the COR told us during the site visit that the work obviously was not completed.

To inspect the tank for cracks, the O&M contractor hired a subcontractor to send a submersible into the tank.<sup>3</sup> However, the COR stated that the submersible was ineffective because it could not “see” through the murky water. The COR also stated that possible debris in the dirty water could clog sprinkler heads, making the fire suppression system ineffective.

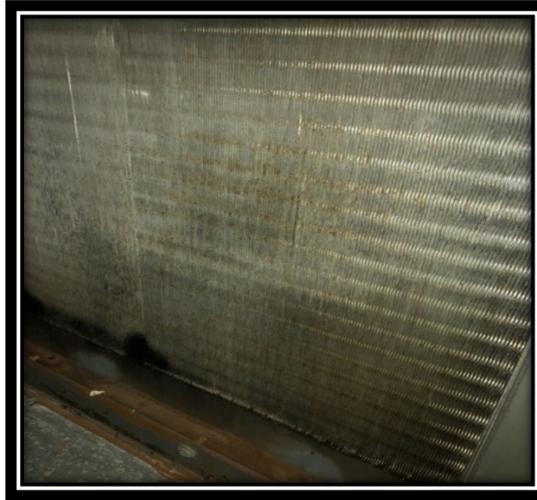
Figure 2 – AHU Coils at the George H. Mahon Federal Building and U.S. Courthouse<sup>5</sup>

The COR inspected the AHU on June 23, 2022, after the preventive maintenance work order was marked complete in NCMMS. In the COR’s inspection of the AHU, they noted that the AHU coils were dirty and needed to be cleaned. The audit team asked the COR if they thought the contractor completed the preventive maintenance work order on April 14, 2022, and if it did, would the coils have been dirty again by the time of their inspection on June 23, 2022. The COR stated that if the contractor completed the preventive maintenance properly, the coils would not have been dirty that soon after cleaning.

We observed the AHU coils during our site visit on May 18, 2023. As shown in *Figure 2* on the next page, we found that the AHU coils were full of dirt and debris.

NCMMS indicated that preventive maintenance on the AHU was completed in April 2023. Despite the condition of the AHU coils during our visit on May 18, 2023, the contractor still marked the work order as complete in NCMMS. However, the contractor did not complete the preventive maintenance properly, like the COR experienced in June 2022.

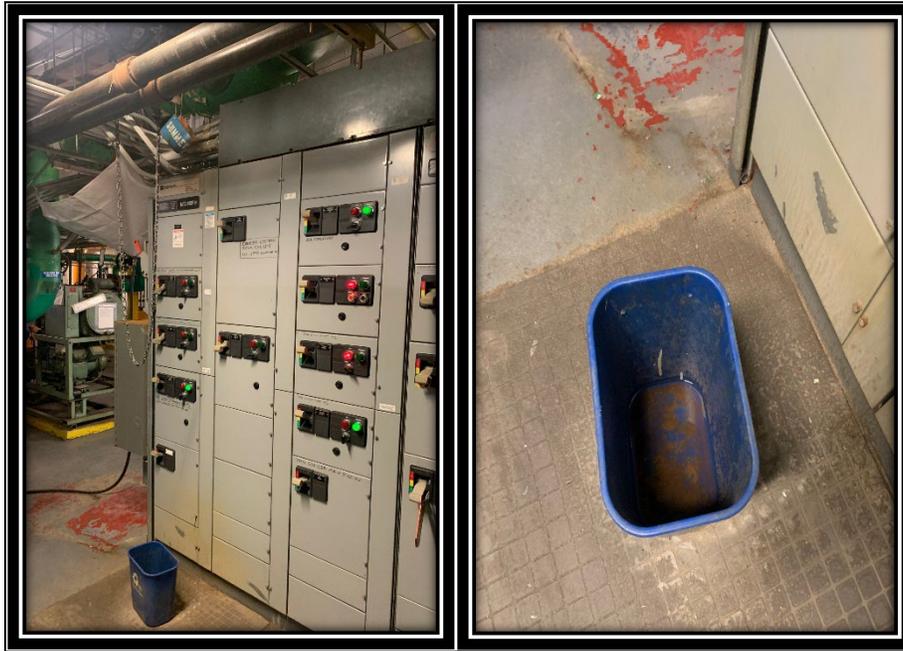
**Figure 3 – Motor Control Center at Jacob K. Javits Federal Building with Blue Recycling Bin to Collect Water from Leaking Valve<sup>6</sup>**

- **Service Request Work Order: Pipe Valve Leak – Jacob K. Javits Federal Building, New York, New York** – The PBS equipment specialist created this work order to fix a pipe valve that was leaking over a motor control center. A motor control center is an electrical panel that allows a technician to turn off building equipment from a central location, rather than forcing them to go to each piece of equipment individually.

We observed the motor control center during a tour of the building on January 19, 2023. As shown in *Figure 3* on the next page, we found that water was leaking from a valve located above and just in front of the motor control center. According to the PBS equipment specialist, a leaking valve over a motor control center can cause corrosion of electrical components, mechanical parts failure, short circuits, possible fires, and can shock someone who touches the cabinet.

The O&M contractor marked the work order in NCMMS as being completed on November 14, 2022. However, as shown in *Figure 3*, the leak was not fixed; therefore, the O&M contractor did not complete the work.

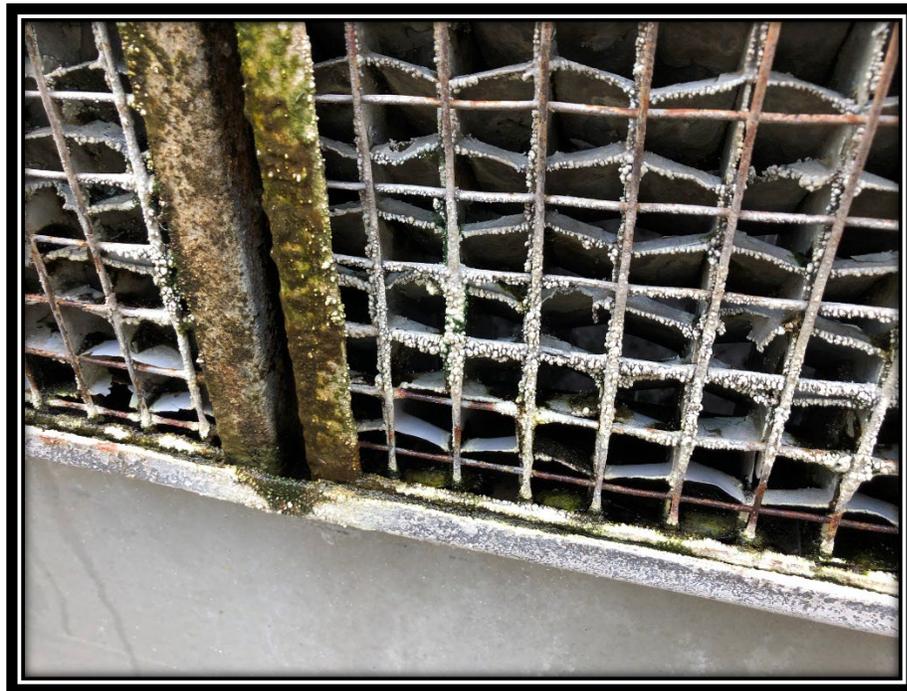
**Figure 4 – Biological Growth and Scaling on the Cooling Tower at the Sam Nunn Atlanta Federal Center<sup>9</sup>**

- **Preventive Maintenance Work Order: Cooling Tower Cleaning – Sam Nunn Atlanta Federal Center, Atlanta, Georgia** – A cooling tower helps control the climate inside a building by removing heat from a building’s water supply and returning cold water to the building’s chiller where it can be used for air conditioning. According to the PBS preventive maintenance standard listed on the NCMMS work order, the cooling tower should be cleaned every 3 months.<sup>8</sup>

We observed the cooling tower during our site visit on May 16, 2023. As shown in *Figure 4* below, we observed green, biological growth and white scaling on the cooling tower “fills.” We asked the COR if we could look inside the cooling tower and requested that the O&M contractor remove the screens. The contractor employees had trouble removing them due to significant calcification caused by a lack of maintenance.

This work order was scheduled to be completed in October 2022, but was not marked complete until December 2022. According to the PBS *Public Buildings Maintenance Standards*, preventive maintenance for cooling towers should be done quarterly; therefore, another cleaning should have been completed in March 2023. Due to the

We subsequently reviewed the work order history for the cooling tower and found that all preventive maintenance work orders were cancelled from April 2023 forward. In addition, 1 day after our visit, the COR created a new work order in NCMMS for the preventive maintenance, but subsequently cancelled it as well.

We asked the O&M contractor about the cancelled preventive maintenance work orders. The project manager for the O&M contractor stated that they, in conjunction with the COR, decided to no longer service the cooling towers at this building because they were being decommissioned and replaced at a future date.<sup>10</sup> Nonetheless, the long-term failure to clean the cooling tower significantly increased potential risk of disease, system inefficiency, and corrosion.

<sup>10</sup> We confirmed that PBS replaced the cooling towers in October 2023.
